LEAK DETECTION REPORT

285 Boulder Bridge Anytown

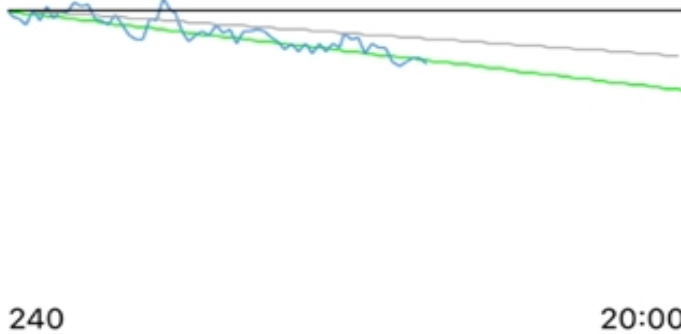
Thu, Sep 09, 2021, 14:32 - Initial

Notes:	Total water loss estimate could be low due to water draining back to pool from the equipment after pump was shut off.
---------------	---

Inches/hour	Inches/day	Gallons/day
Total Loss	0.01	0.32	156
Est. Evap.	0.01	0.19	93
Leak	0.01	0.13	63

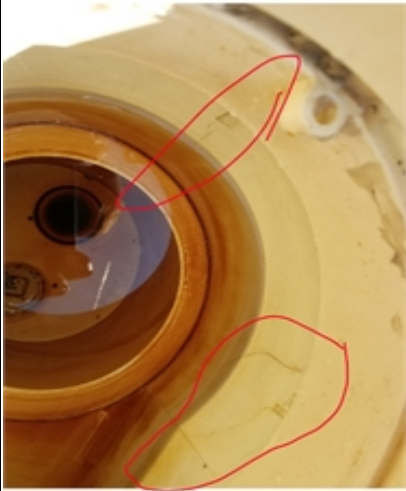
Deep SKIMMER

<p>Problem Description: Crack in bowl Three Cracks in bowl</p>
	<p>Patched: Yes</p>
	<p>Notes: Repaired with Leakmaster Pool Repair Putty.</p>

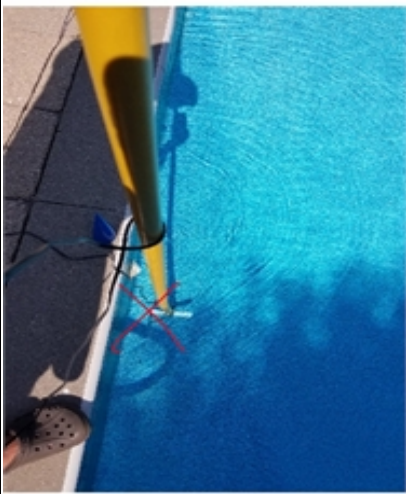
LINER

<p>Problem Description: Puncture Deep wall left from deep end puncture in liner. Cut was 1" in length.</p>
	<p>Patched: Yes</p>
	<p>Notes: Leakmaster Flexible Sealer and vinyl patch.</p>

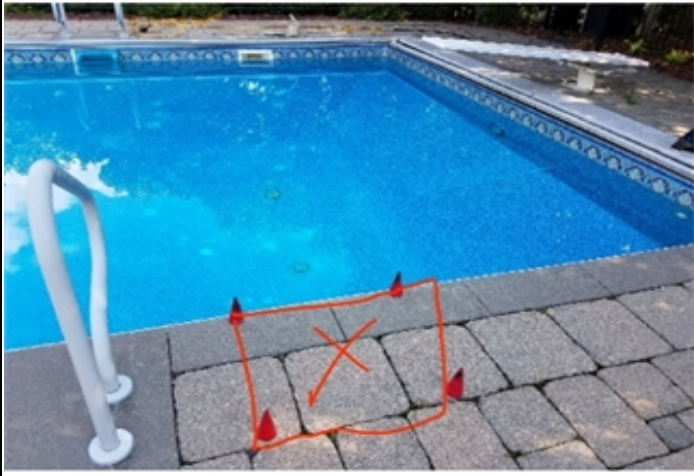
PRESSURE SIDE PLUMBING (RETURNS)

Section	Pressure Test Results	Conclusion
Shallow Return Line	Air pressure test back to valve. Could build pressure up but did not hold pressure.	FAIL

Problem Description:

Leak in shallow return line.

Leak in line below the pavers in box area.

Fix or abandoned shallow return line. Monitor water level before winter loss.

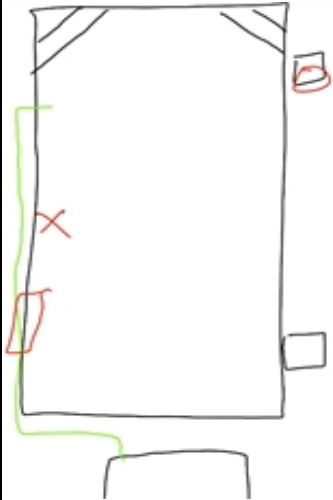
PROBLEM LOCATION DIAGRAM

Three Leaks. Red X is Liner leak. Red circle is skimmer leak. Red rectangle is shallow return line leak underground.
